Customer	
Address	
Tel	
Location	
Contact	
Tel	
Email	
Customer Order Number	
Job Number	EJC65-070-09
Incoming	21/9/2022
Finish	24/9/2022

Multi-Turn Actuators - L120

Actuator Overhaul Report

Actuator Description				Gear Box		
Tag No.	HV-1807			S/N		
Actuator S/N	L833958			Ratio		
Order No.	16-477-3957-3-REV-A1			Type		
Type	L120-190			Manufacturer		
Output speed	20-160 rpm.					
Torque	2584 Nm.			Valve Description		
Motor Rating	25 KW 15Min			Size		
VOLTS.	380	PH.	3	HZ.	50	
L.R. AMPS	9	Amp.			Class	
RUN AMPS		Amp.			Manufacturer

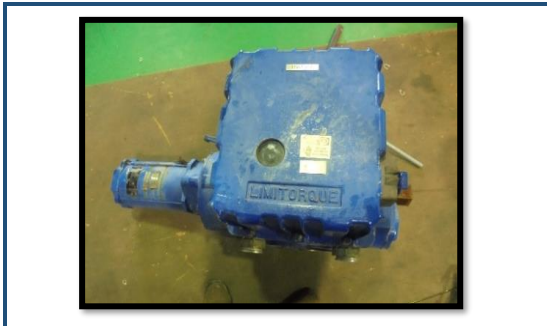
Fig 1. Visual Check the Actuator at Shop

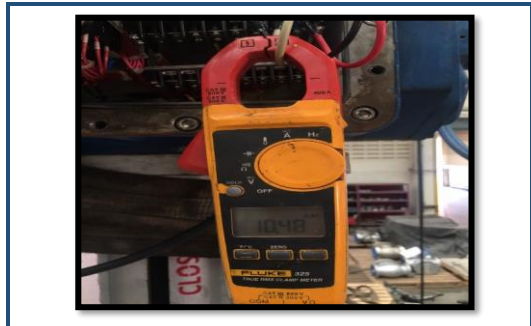
Fig 2. Current of Phase 1 (Before)

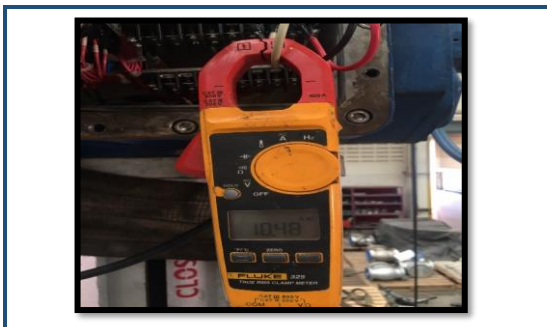
Fig 3. Current of Phase 2 (Before)

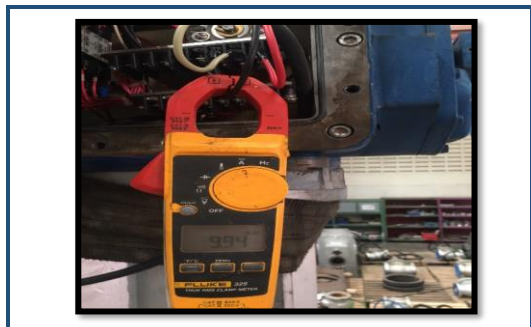
Fig 4. Current of Phase 3 (Before)

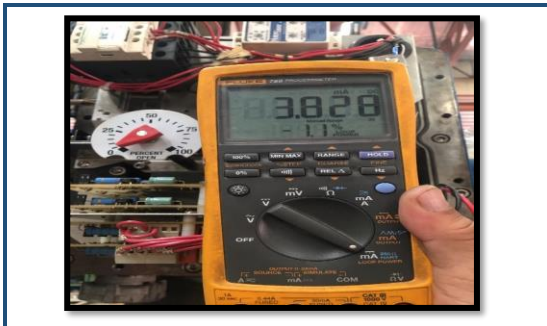
Fig 5. Feedback Signal 0% (Before)

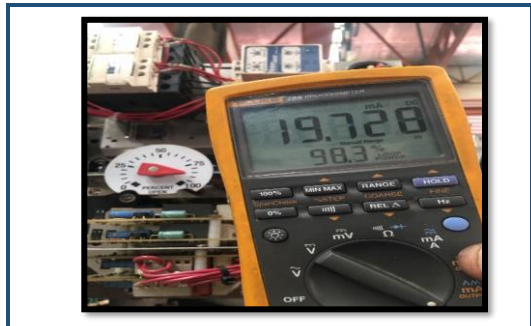
Fig 6. Feedback Signal 100% (Before)

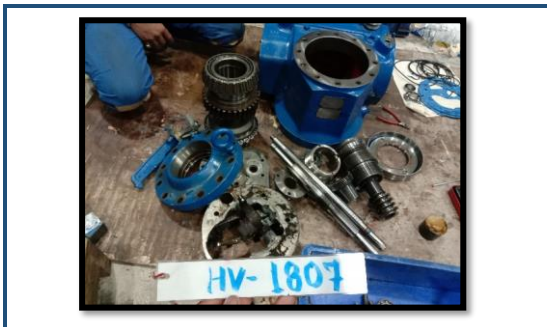
Fig 7. Remove Actuator at Shop

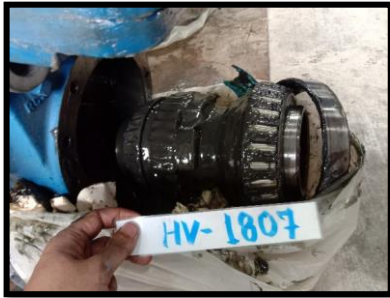
Fig 9. Inspect Center Column

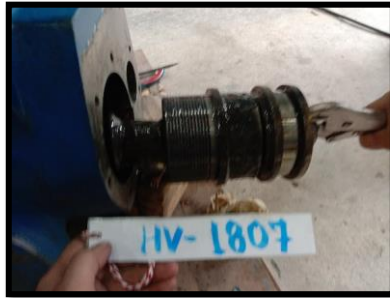
Fig 10. Inspect Spring Torque

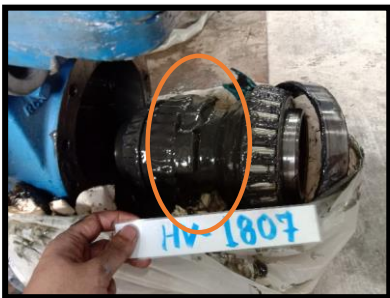
Fig 11. Inspect Worm Gear

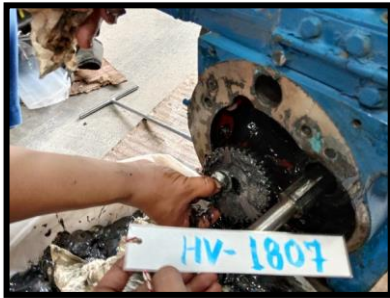
Fig 13. Inspect Gear Shaft Motor

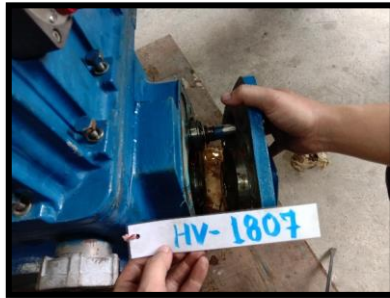
Fig 14. Inspect Shaft Hand Wheel

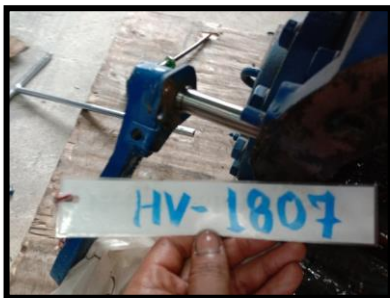
Fig 15. Inspect Declutch Lever

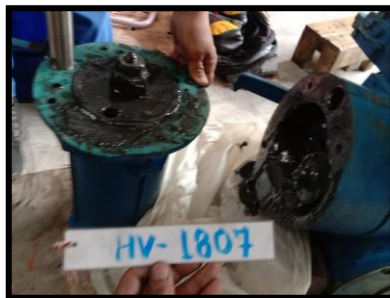
7. Motor Assembly	Pass	Fail	Comment	
Insulation Test(Flash Test at 500VDC)	<input checked="" type="checkbox"/>	<input type="checkbox"/>	U-G = $\geq 550M \Omega$ V-G = $\geq 550M \Omega$ W-G = $\geq 550M \Omega$	
Windings	U-V = 2.91 Ω U-W = 2.82 Ω V-W = 2.83 Ω			
Thermal	0.68 Ω			
Heater	2095 Ω

Fig 16. Inspect Motor of the Actuator

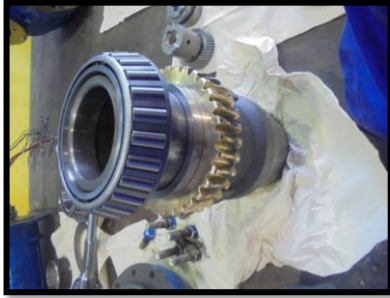
Fig 17. Cleaning Center Column

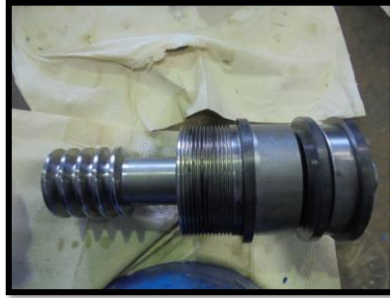
Fig 18. Cleaning Spring Torque

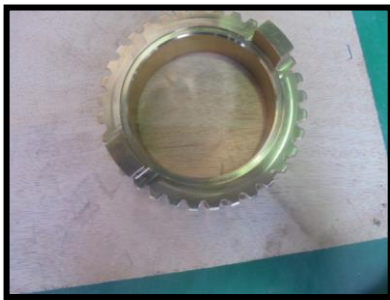
Fig 19. Cleaning Worm Gear

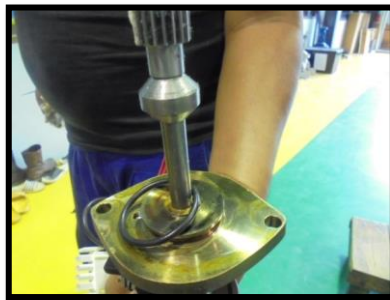
Fig 20. Cleaning Gear Torque Switch

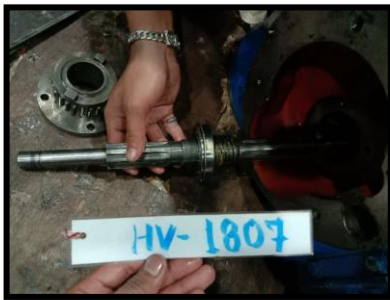
Fig 21. Cleaning Gear Shaft Motor

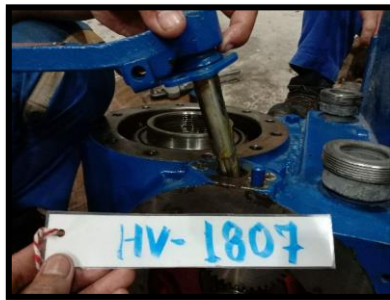
Fig 22. Cleaning Shaft Hand Wheel

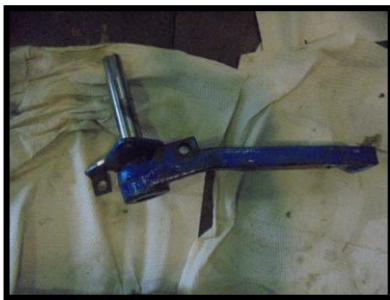
Fig 23. Cleaning Declutch Lever

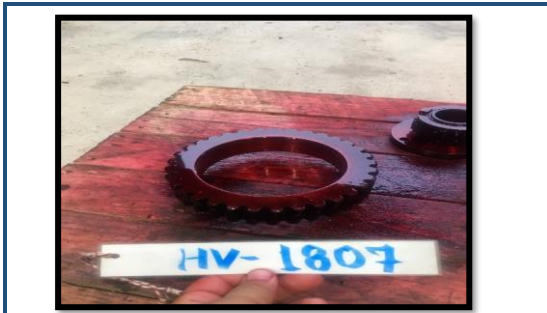
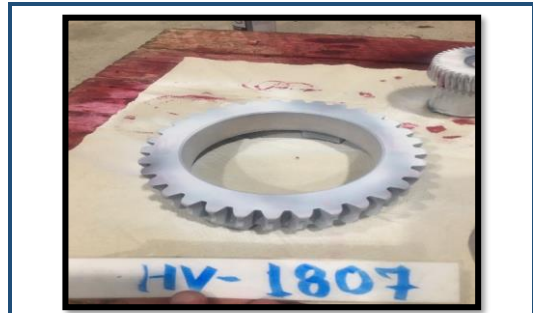
Fig 25. Inspection by Penetrant Testing (PT Test) Worm Gear

Fig 26. Inspection by Penetrant Testing (PT Test) Worm Gear

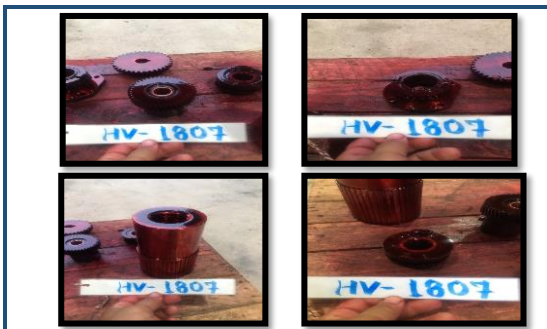
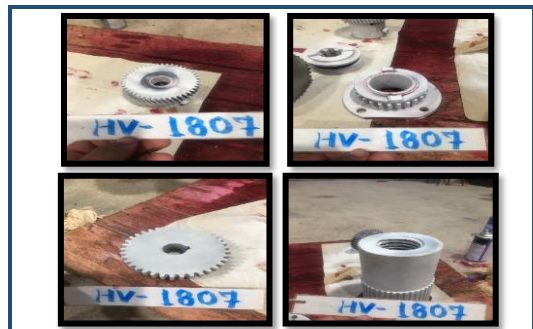
Fig 27. Inspection by Penetrant Testing (PT Test) Gear Shaft Motor

Fig 28. Inspection by Penetrant Testing (PT Test) Gear Shaft Motor

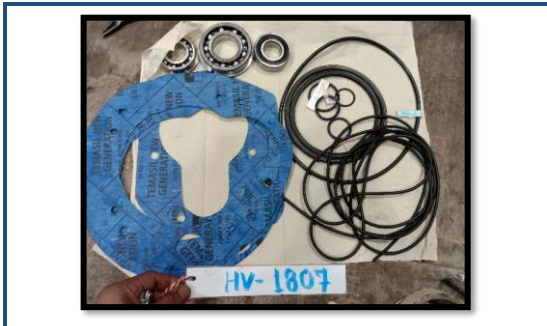
Fig 29. New Part Kit for Overhaul

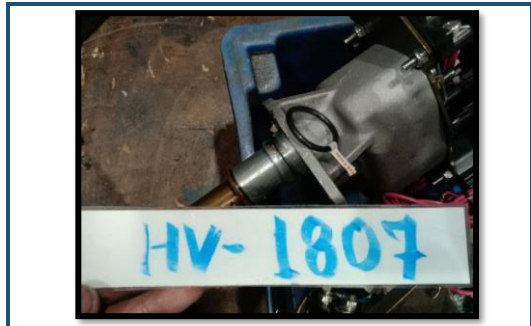
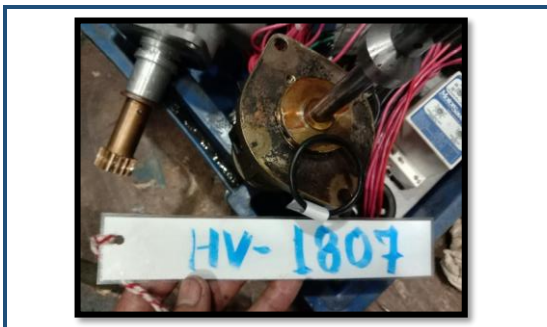
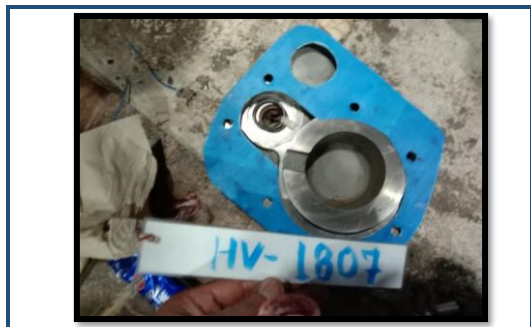
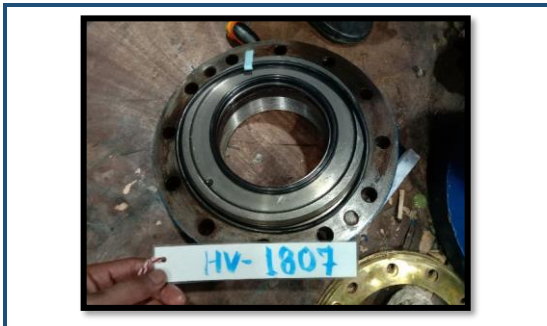
Fig 30. Change New O-ring

Fig 31. Change New O-ring

Fig 32. Change New O-ring

Fig 33. Change New O-ring

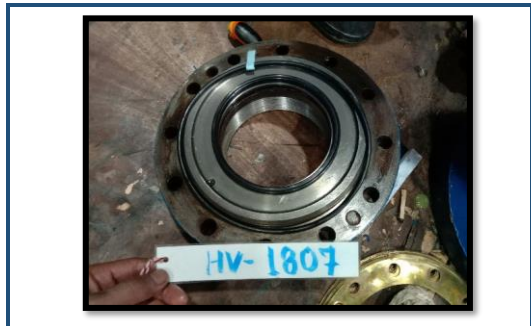
Fig 34. Change New X-ring

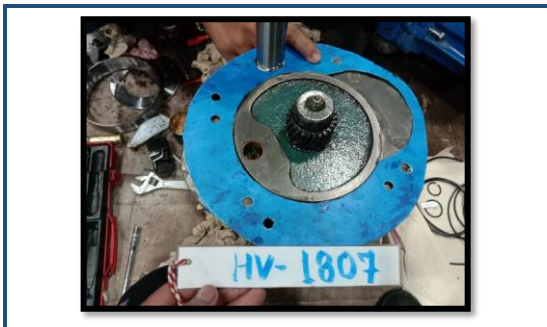
Fig 35. Change New Gasket

Fig 36. Change New Gasket

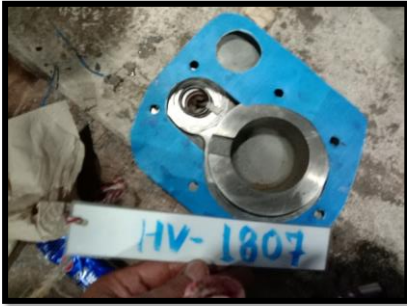
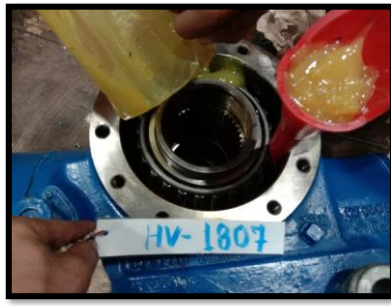
Fig 37. Change New Grease

Fig 38. Change New Grease

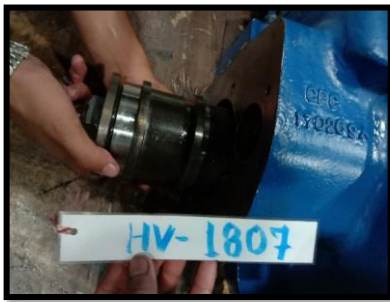
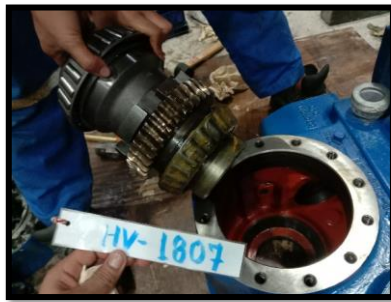
Fig 39. Assembly Mechanic Part

Fig 40. Assembly Mechanic Part

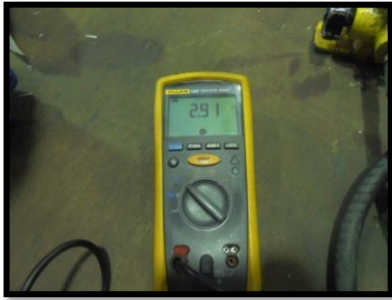
Fig 42. Coil Resistance 1 Test

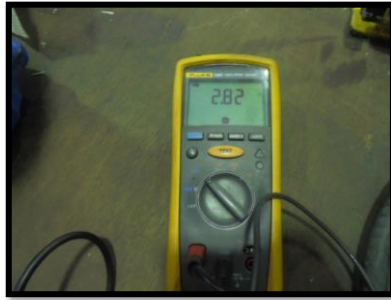
Fig 43. Coil Resistance 2 Test

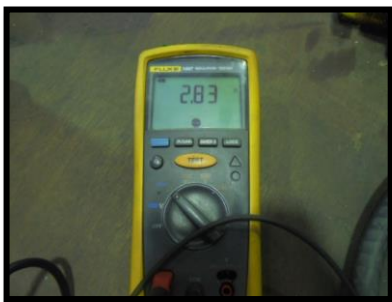
Fig 44. Coil Resistance 3 Test

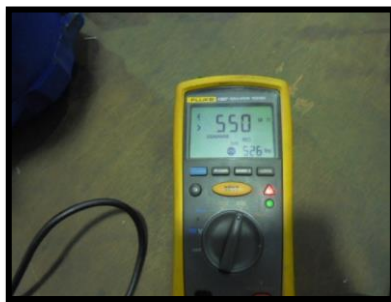
Fig 45. Insulation UI-G Test

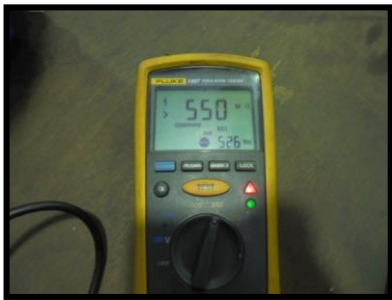
Fig 46. Insulation V1-G Test

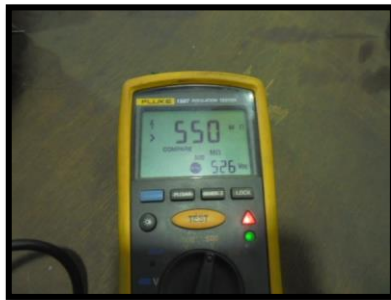
Fig 47. Insulation W1-G Test

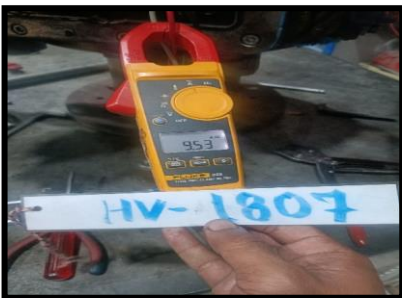
Power Measurement	Before	After	Function Test	Before	After
Voltage Between Phase 1 & 2	417.8 V.	405.4 V.	Manual Operation	✓	✓
Voltage Between Phase 1 & 3	421.9 V.	407.6 V.	Local Operation	✓	✓
Voltage Between Phase 2 & 3	421.4 V.	408.1 V.	Local Indication	✓	✓
Current of Phase 1	10.48 A.	9.53 A.	Remote Operation	✓	✓
Current of Phase 2	10.48 A.	9.81 A.	Remote Indication	✓	✓
Current of Phase 3	9.94 A.	9.39 A.	Stoke Time	70.12 Sec.	Sec.

Fig 48. Current of Phase 1 Test (After)

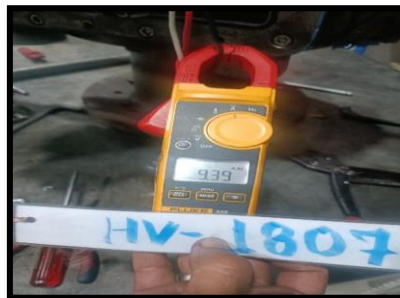
Fig 49. Current of Phase 2 Test (After)

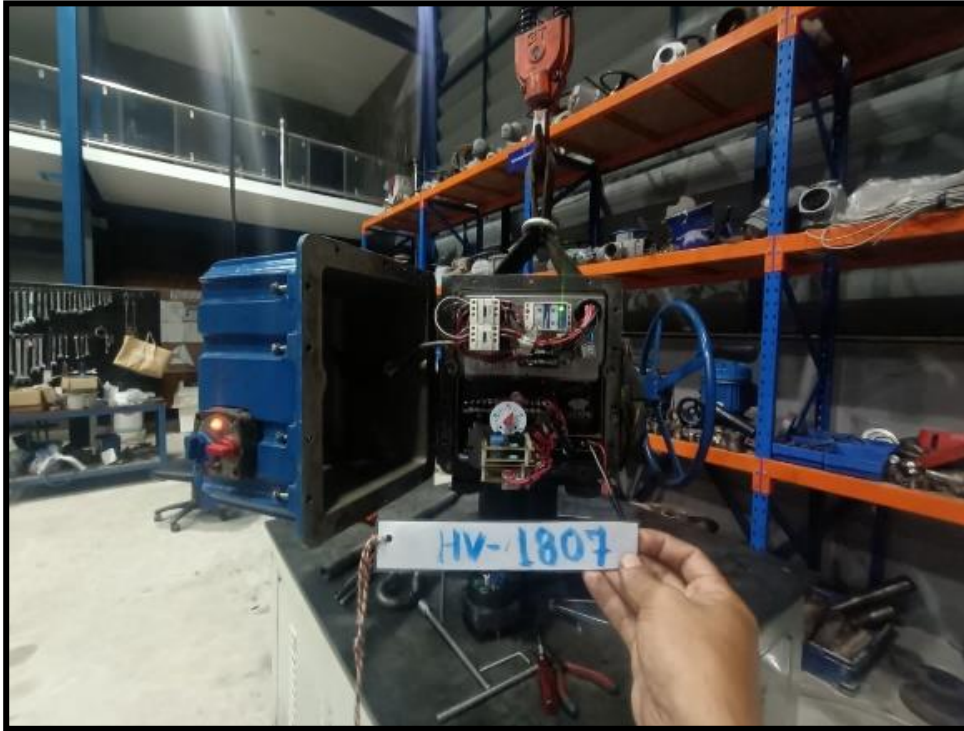
Fig 51. Disassembly Gear Torque Switch
